# Repeated loads above the proportional limit on 24ST aluminum alloy

REPEATED LOADS ABOVE THE PROPORTIONAL LIMIT  
ON 24ST ALUMINUM ALLOY

In Partial Fulfillment of  
The Requirements for the Professional  
Degree in Aeronautical Engineering

California Institute of Technology  
Pasadena, California

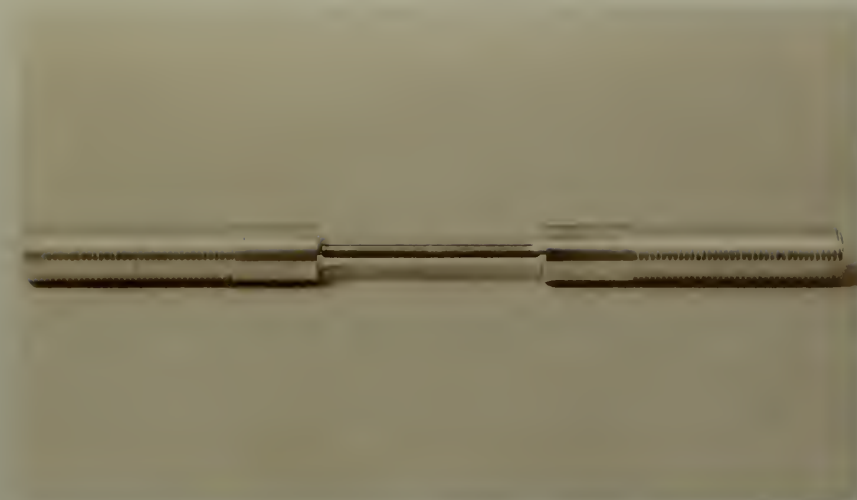
Fig. 3  
Test Speciman

Fig. 3 is a photograph of one of the specimens.

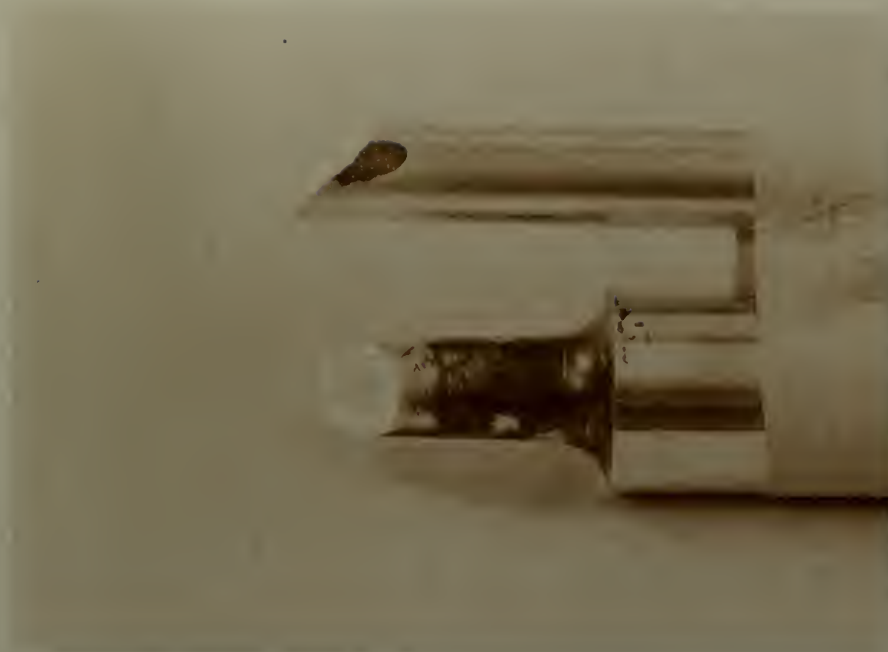
FIG. 13  
 Photograph of Fractured Specimen  
 No. 12 Showing Failure in Shear.

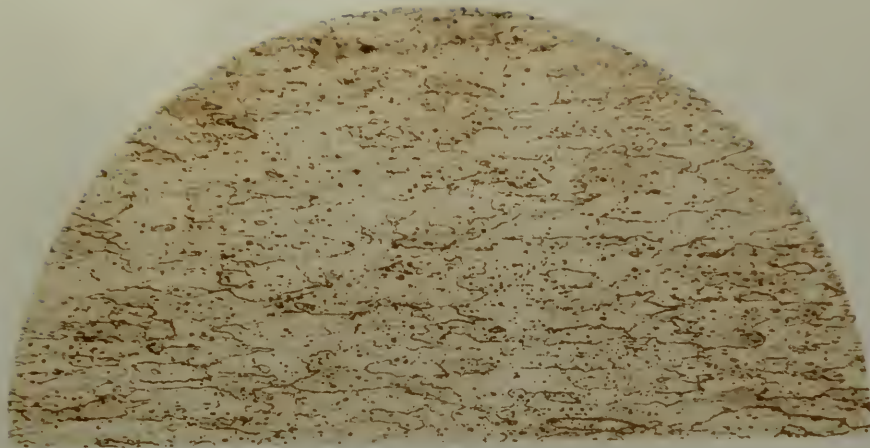
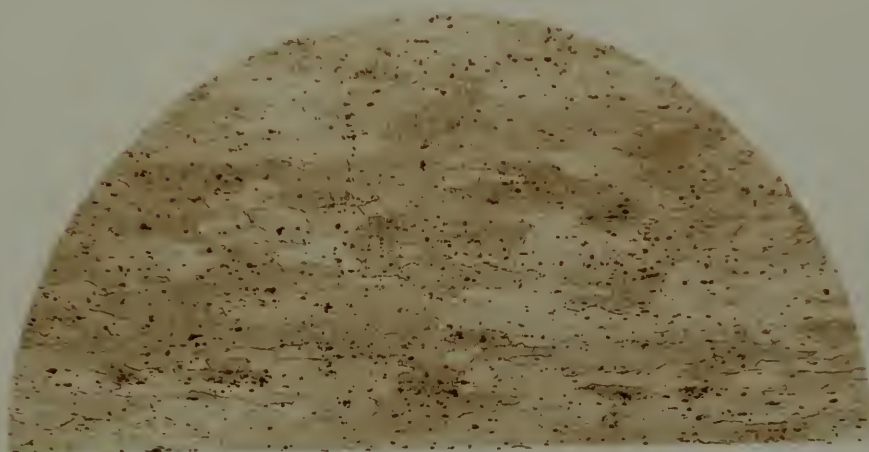
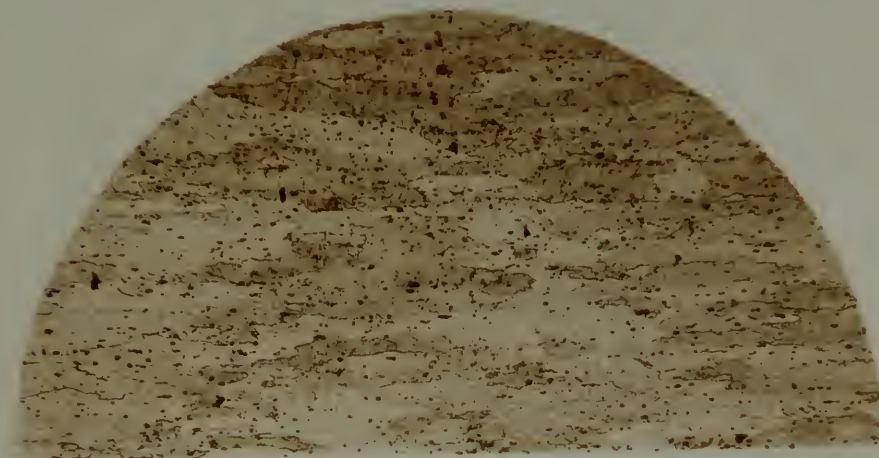
Spec. No.4

Spec. No.3

Spec. No.5

varying values of stress cycles although they were from the same batch of material and were worked at the same stress, the question arose as to whether there might be internal evidence to indicate the reason. Hence photomicrographs were made of the fractured specimens. Fig. 19 shows the profiles of the fractures and the adjacent grain structure. As might be expected, the fracture profiles show the increase in brittleness with increase in number of applied cycles. However, the grain structures are essentially the same and yielded no clue beyond showing grain orientation in the direction of the applied stress which was to be expected. Fig. 20 is a photomicrograph of the same three specimens in a low stress region and here again is barren of results beyond showing that the grain structure of all are practically identical.
